# Tracy Fish Facility Studies California

## Hydraulic Performance Evaluation of the Replacement Primary Bypass Intakes and Transition Boxes at Tracy Fish Collection Facility

Volume 40

July 2007

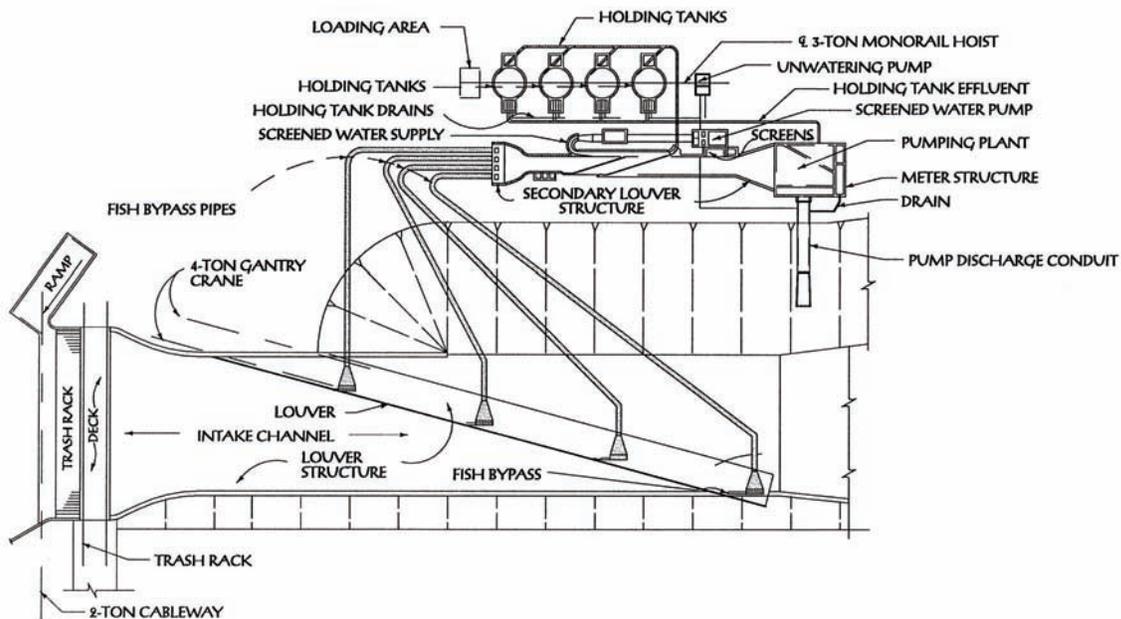
FIGURE 1.—Plan view schematic of Tracy Fish Collection Facility.

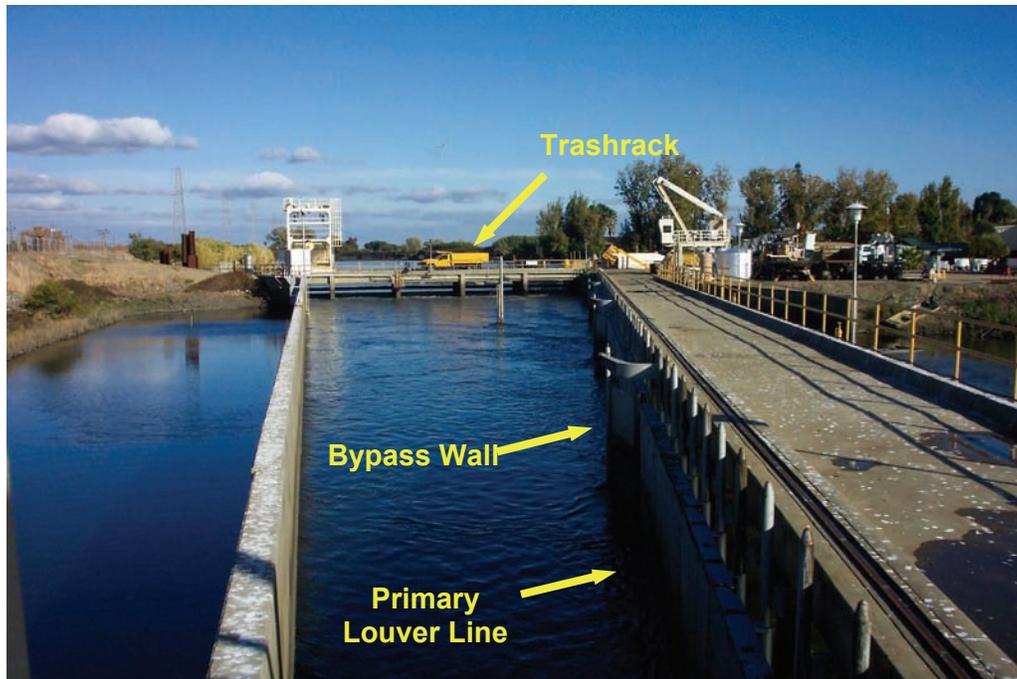
FIGURE 2.—Features in the primary channel looking upstream.

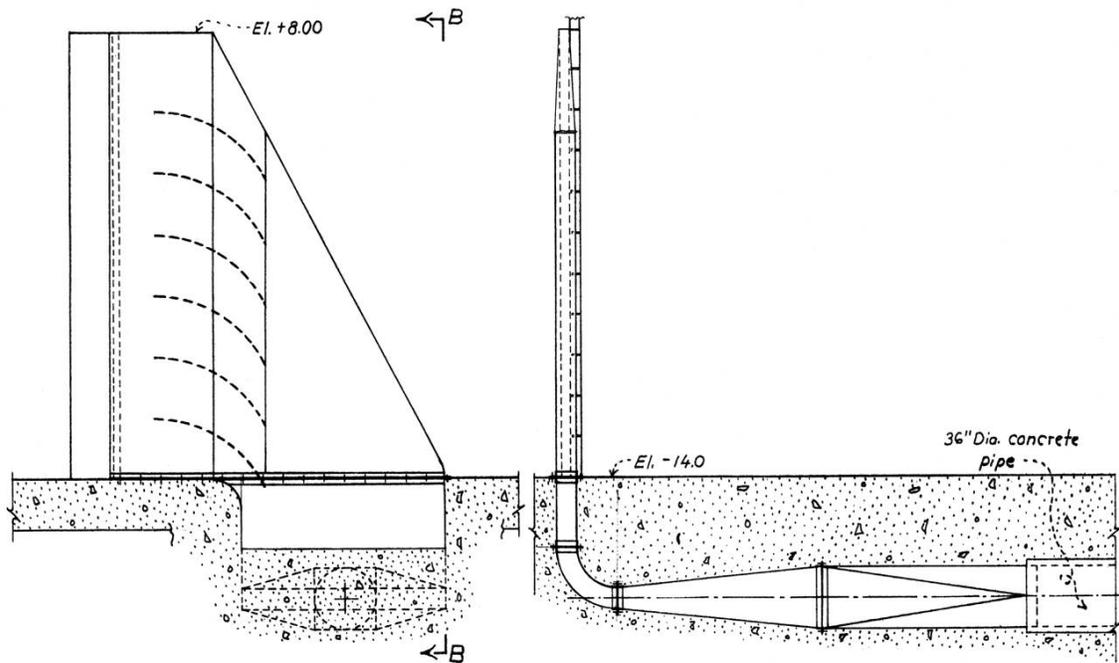
FIGURE 3.—Original bypass intake design using internal curved vanes from 1956.

Although the intakes were designed to generate near-uniform entrance velocity distributions, the vanes were not accessible for maintenance and cleaning. The vanes accumulated debris, causing flow blockages within the intake and degrading

the uniformity of the entrance velocity profiles. As the bypass intakes corroded and deteriorated with time, vane failure reduced velocity distribution control effectiveness and holes in the bypass transition boxes were observed.

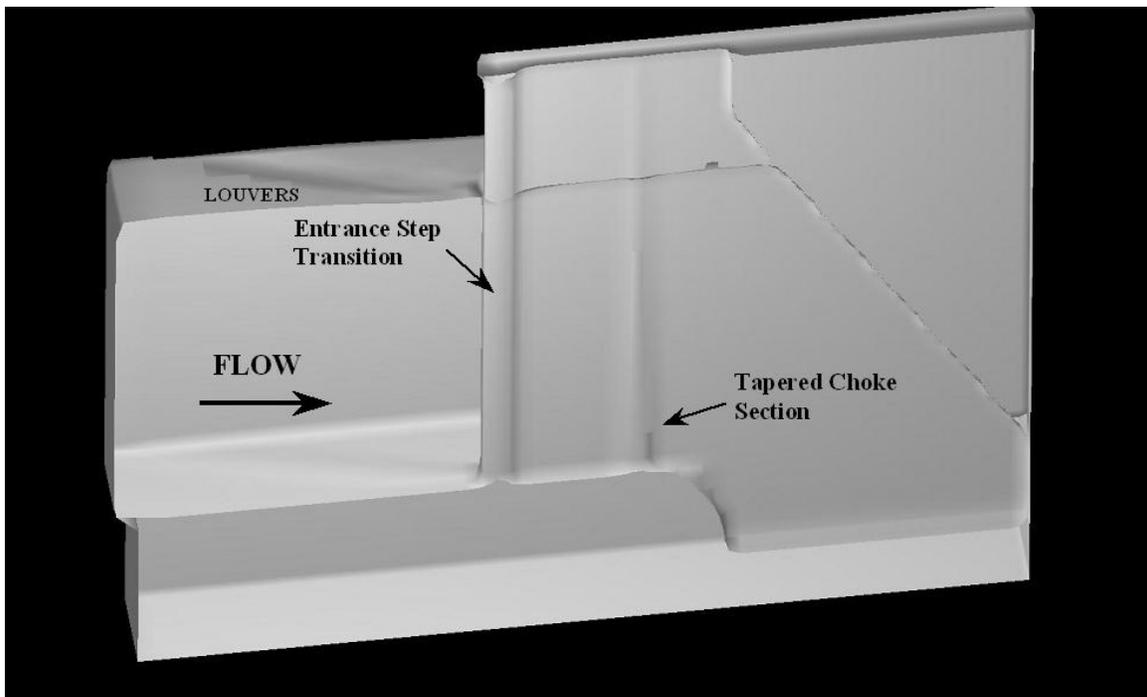
FIGURE 4.—Replacement bypass intake design using a tapered choke section (Kubitschek, 2003).

Because of corrosion and failure of both the vanes and the skin of the transition boxes, an effort was initiated in 2001 to replace the four primary bypass intakes. The bypass intakes were repaired in the spring of 2003 and the replacement bypass intakes were installed at the TFCF in the spring of 2004. The intakes and transition boxes were designed based on physical and computational hydraulic model studies (Kubitschek, 2003). The replacement design used a tapered choke (vertically tapered section) to generate a near-uniform vertical velocity without the need for internal turning vanes (figure 4). This design constricts the intake flow path with a linear expansion from the bottom to the surface, vertically balancing the velocity potential at the intake entrances. The advantage of this design is that debris accumulation may be reduced to sustain effective operation.

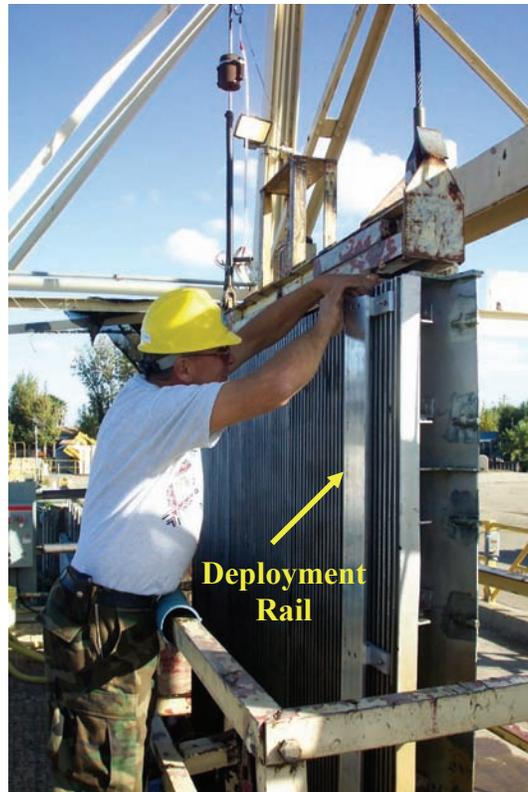
FIGURE 5.—An ADV deployment rail was affixed to the louver panel just upstream from the bypass entrance.

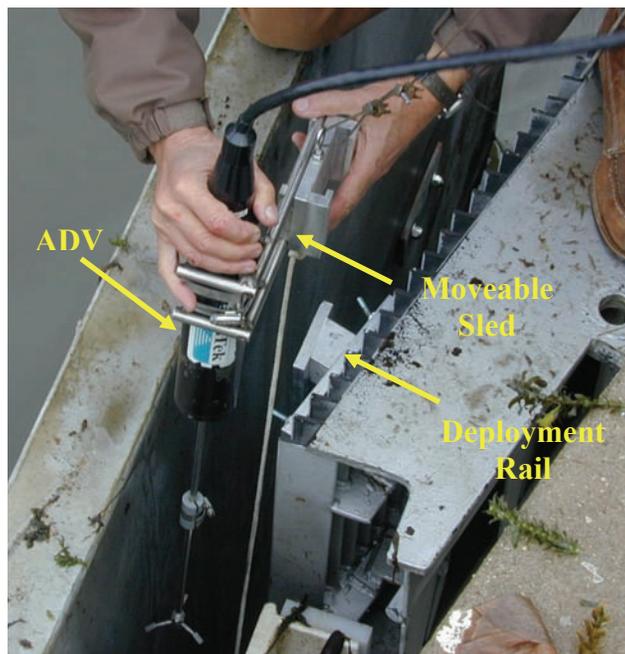
FIGURE 6.—The ADV was attached to a moveable sled to vertically position the instrument along the rail.

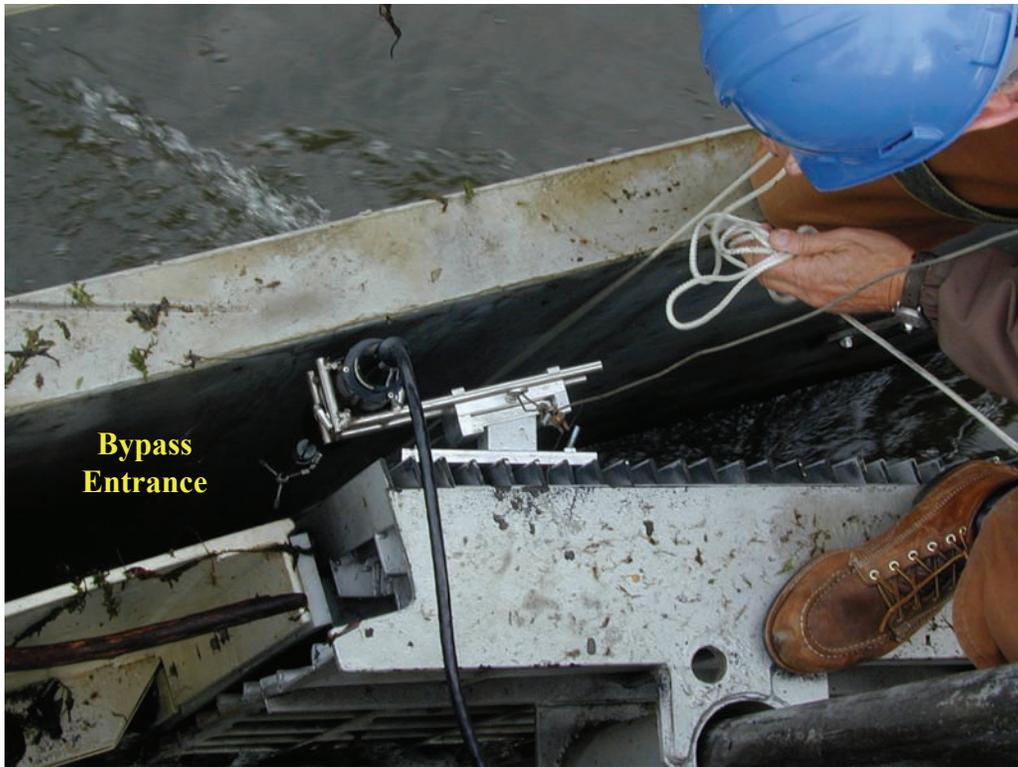
FIGURE 7.—The ADV was lowered down on the deployment rail into the bypass entrance.

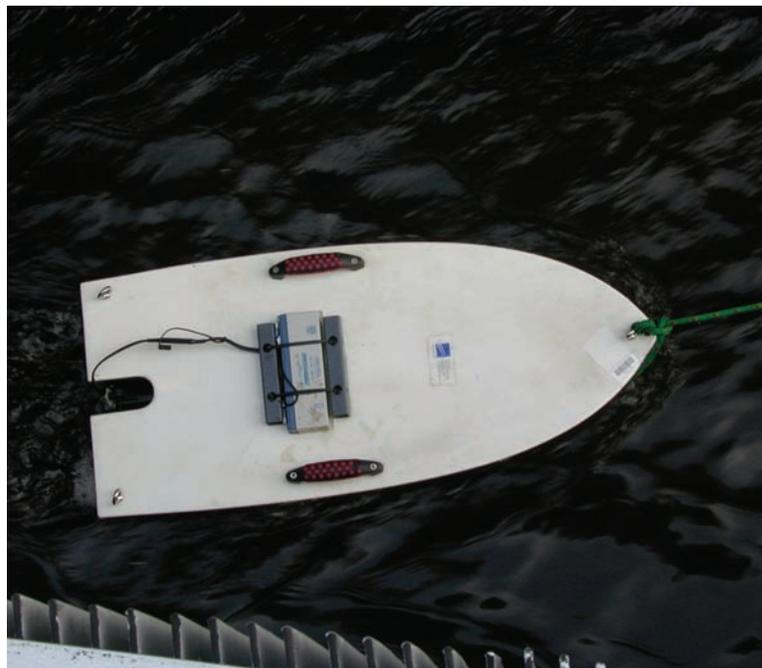
FIGURE 8.—Nortek BoogieDopp velocity profiler.

Near-field approach velocity profiles upstream from the intake were collected with the Nortek BoogieDopp instrument which was replaced by the Qmetrix Qliner in 2004 (figure 8). This instrument utilizes acoustic Doppler technology to measure velocity profiles with an accuracy of 1 percent of the measured value  $\pm 0.016$  ft/s (0.5 cm/s). A current profiler is mounted on the bottom of a boogie board. The BoogieDopp is easily deployed from land since it collects data in a Pocket PC through a wireless radio modem. The instrument records velocity values in a series of depth cells throughout the water column. Velocities are averaged over a 5-second period for each 15 cm depth cell during the measurement duration of 60 seconds.

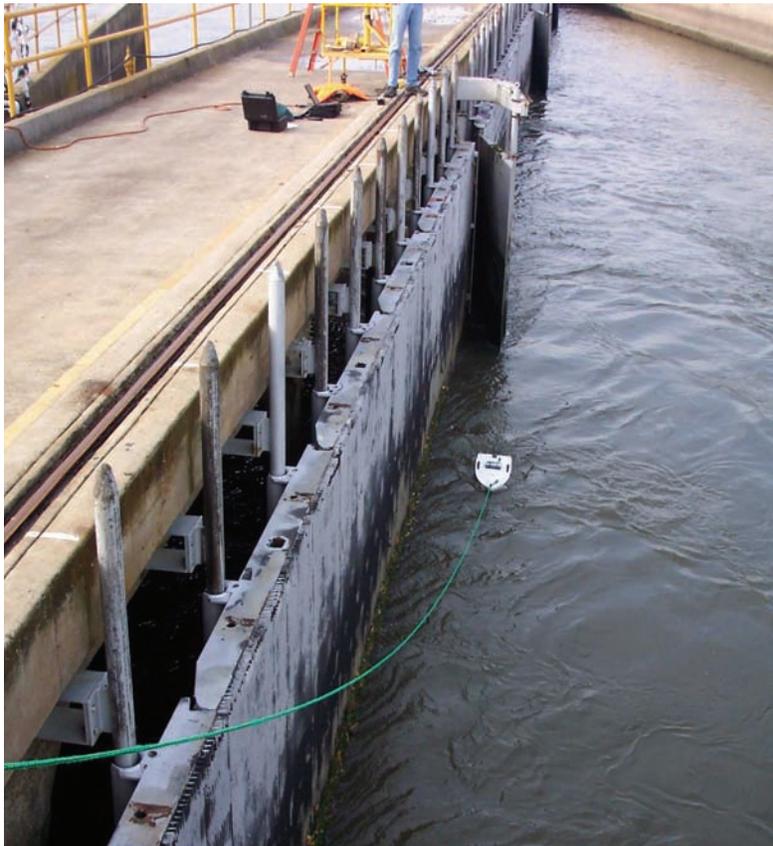
FIGURE 9.—The BoogieDopp was positioned upstream from the intake entrance to document near-field approach velocity conditions.

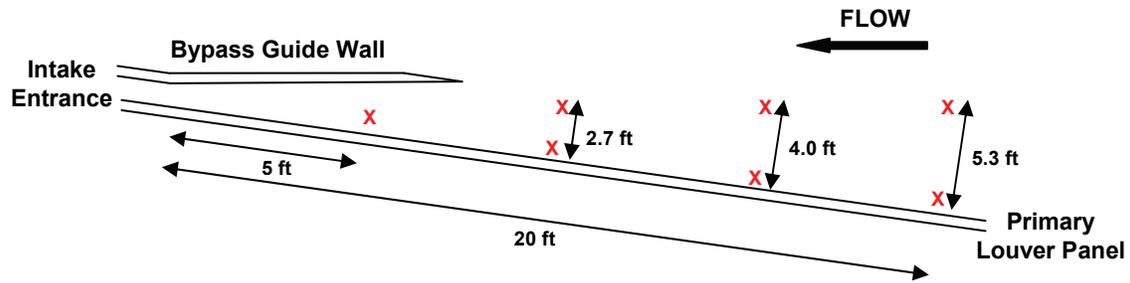
FIGURE 10.—Schematic of velocity profile locations (indicated by **X**) upstream from the intake entrance. Profiles were measured against the louver panel face and several feet away from the louvers.

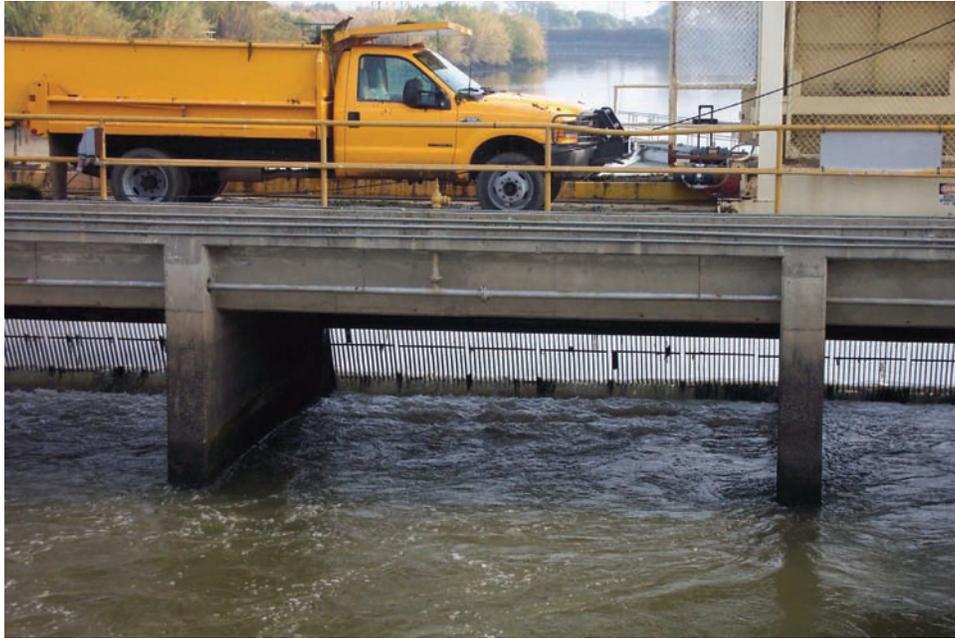
FIGURE 12.—Trashrack fouling was documented during data collection.

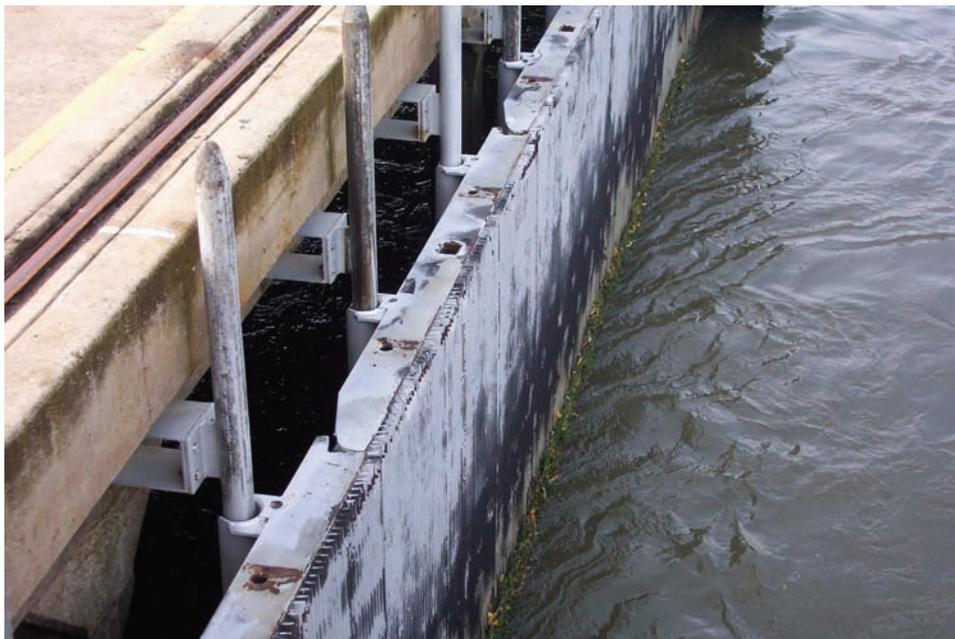
FIGURE 13.—Louver panel fouling was documented during data collection.

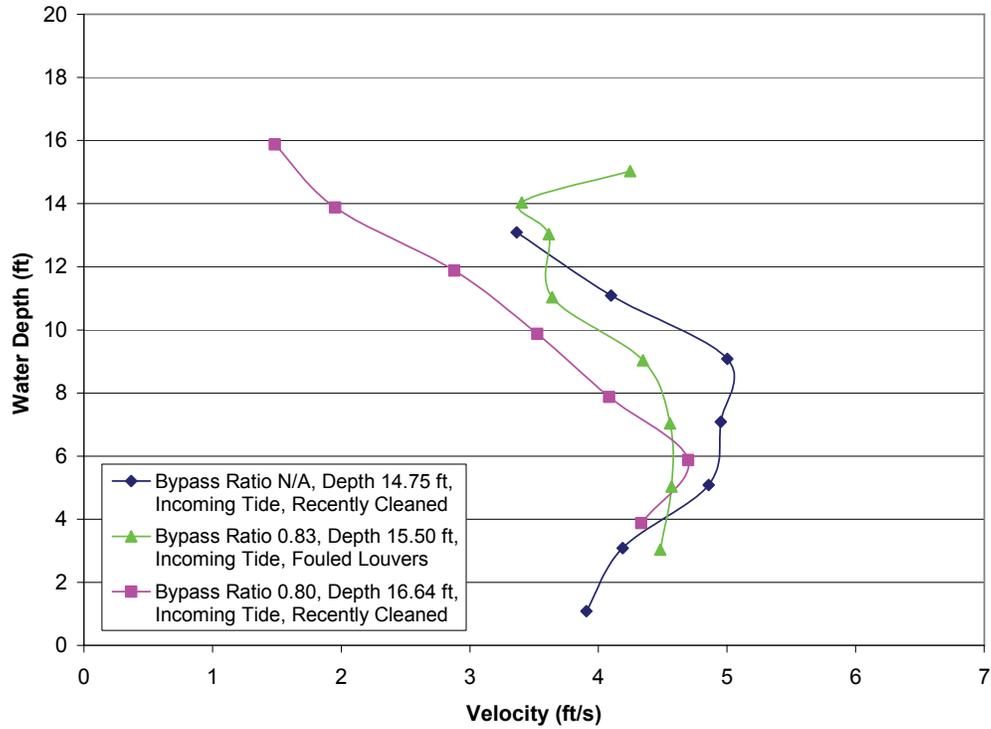
FIGURE 14.—Velocity profiles in the original primary bypass 1 intake entrance.

The downstream velocity components are presented below for various bypass ratios, water depths, and debris conditions. Original intake velocity profiles for bypasses 1 and 2 are shown in figures 14 and 15 and the replacement intake velocity profiles for bypasses 1-4 are shown in figures 16-19, respectively. It is difficult to isolate the effect of intake and transition box condition on nonuniformity since approach velocity distributions, debris fouling, and bypass ratio also affect the entrance velocity profiles. However, for the velocity profiles in bypasses 1 and 4 that have similar operating conditions, the replacement intakes produce a slightly more uniform velocity profile than the existing original intakes. Most importantly, figure 19 shows that the replacement bypasses operate as intended when the standing operating procedure of bypass ratios above 1.0 can be achieved. Bypass ratios less than 1.0 show pronounced vertical nonuniformity.

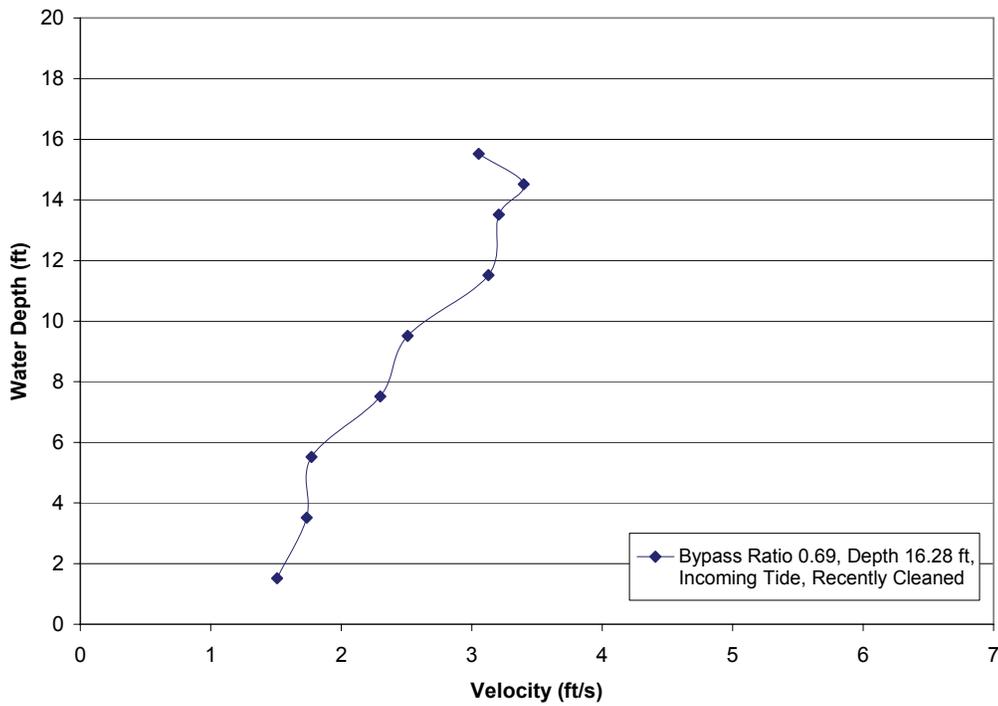
FIGURE 15.—Velocity profiles in the original primary bypass 4 intake entrance.

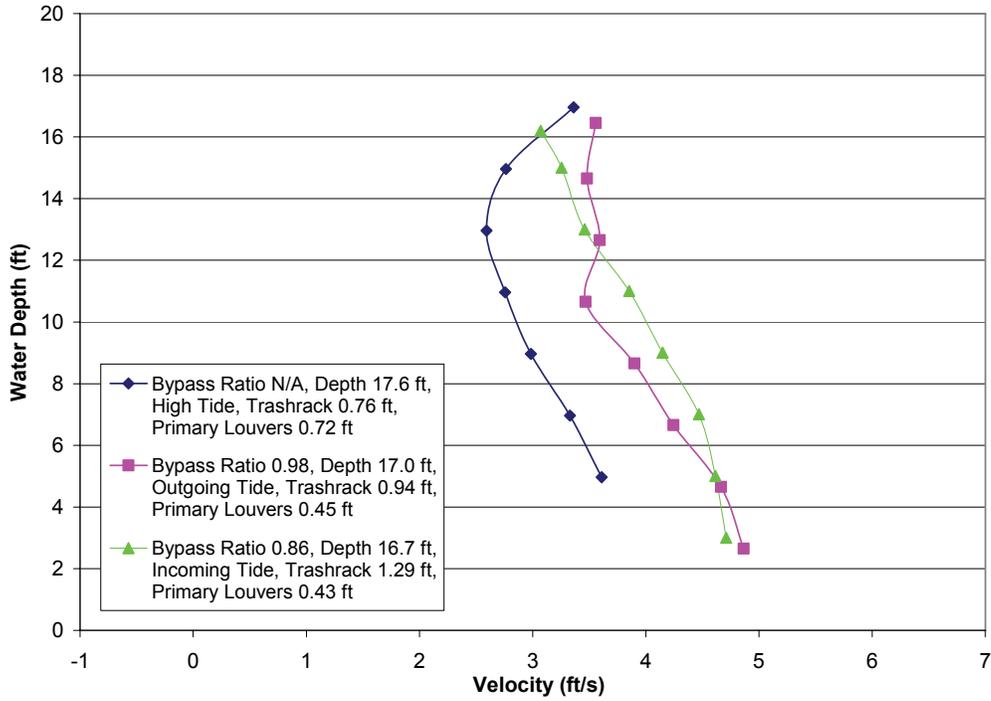
FIGURE 16.—Velocity profiles in the replacement primary bypass 1 intake entrance.

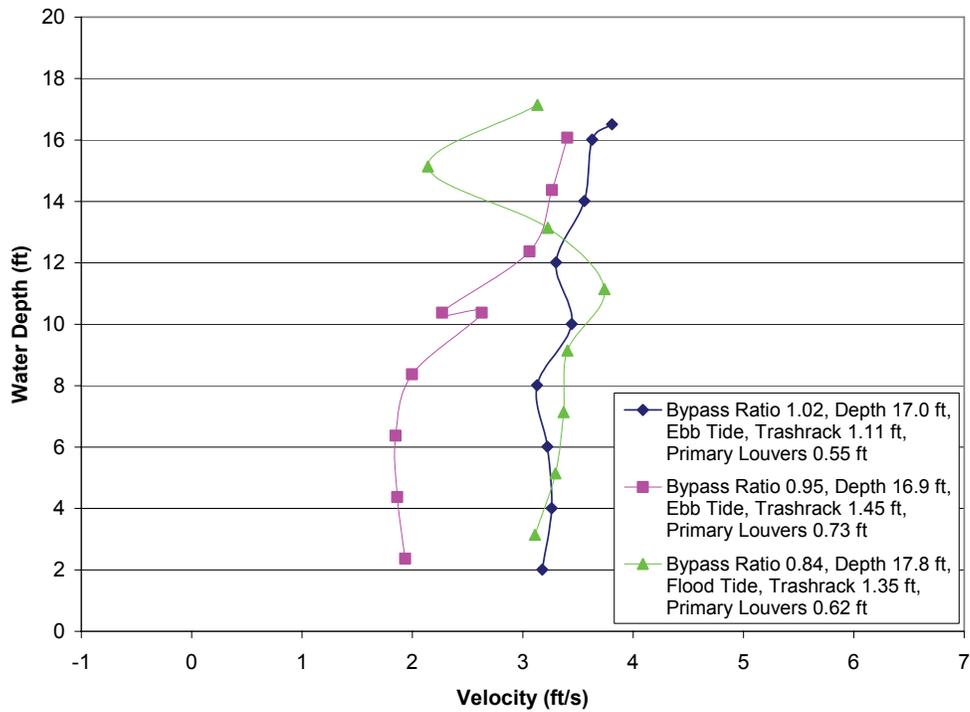
FIGURE 17.—Velocity profiles in the replacement primary bypass 2 intake entrance.

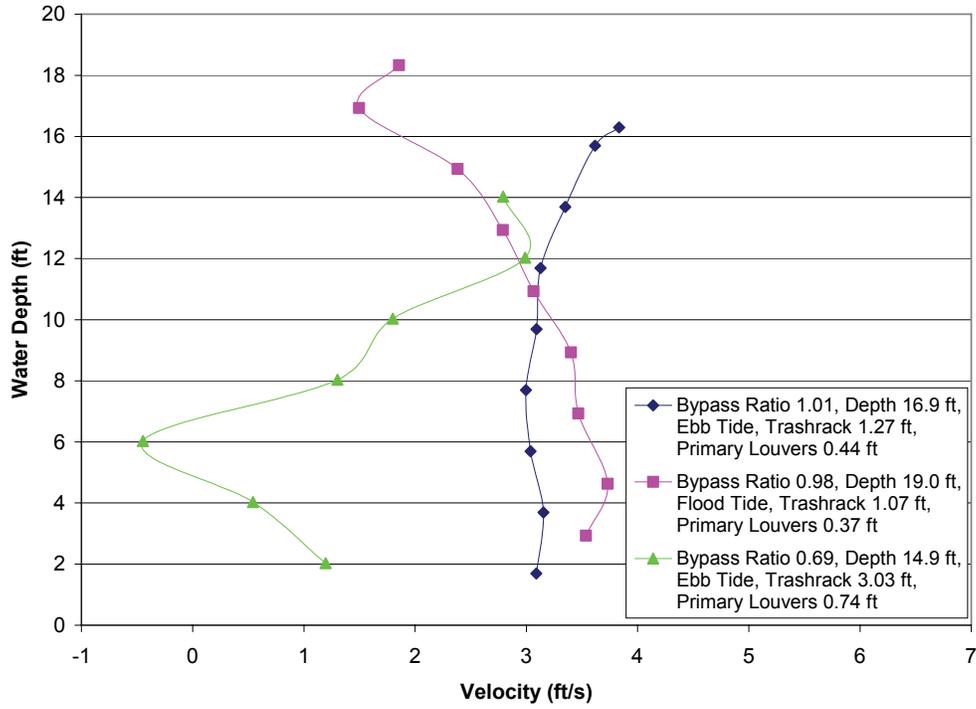
FIGURE 18.—Velocity profiles in the replacement primary bypass 3 intake entrance.

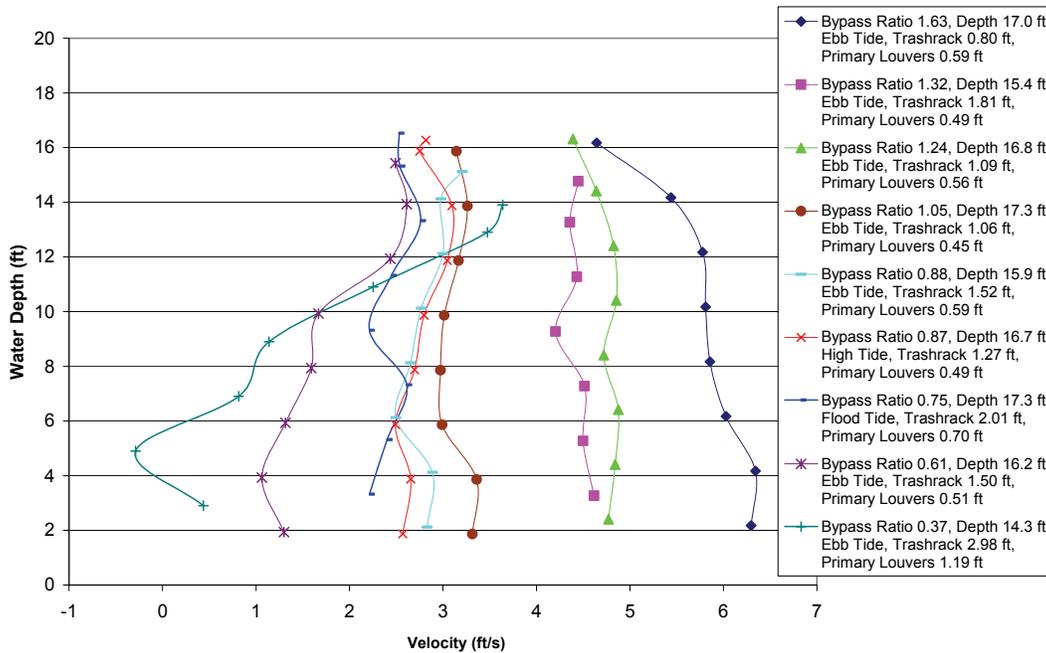
FIGURE 19.—Velocity profiles in the replacement primary bypass 4 intake entrance.

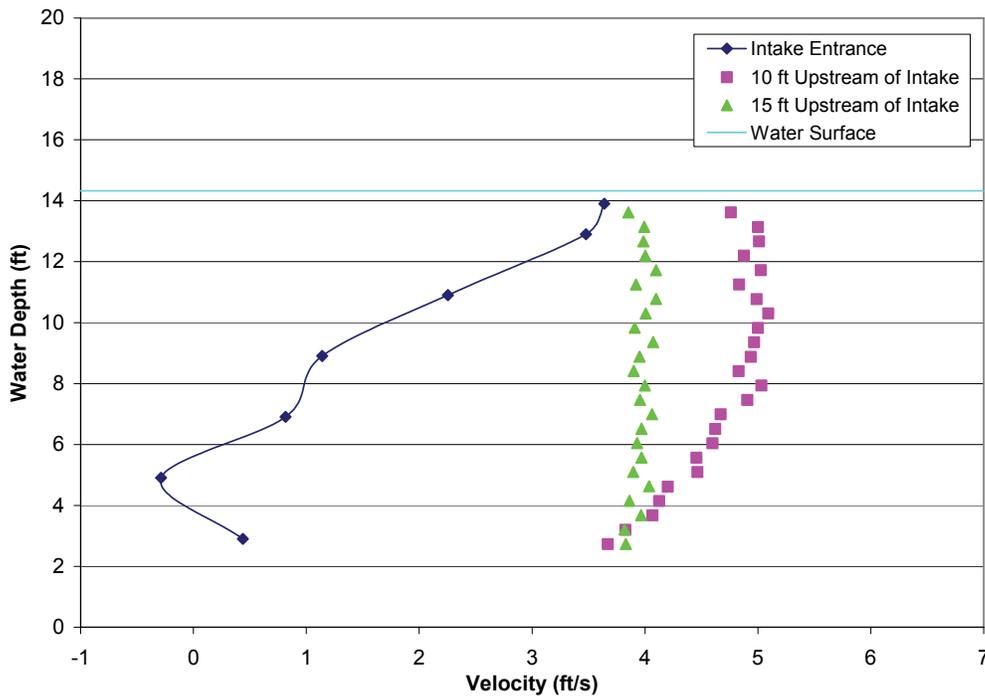
FIGURE 20.—Example of a profile collected with a bypass ratio of less than 1.0. Test 2-4, collected at bypass 4 with a measured bypass ratio of 0.37, shows significant slowing in the approach velocity fields and reverse flows at the intake entrance.

In the laboratory study, bypass ratios of 1.2 and 1.6 were tested due to their significance as TFCF operating criteria. In the field, bypass ratios greater than 1.0 can be difficult to achieve due to tidal conditions, debris influences, and facility limitations. When bypass ratios are well below 1.0, velocity profiles decelerate into the bypass intake (figure 20). This slowing trend negates the intended increase in velocity recommended for guiding fish into the bypass intake. Entrance profiles often show flow patterns that are not present in the approach velocities, indicating that secondary flow patterns and eddies are generated within the transition box due to flow restrictions. This causes non-uniform velocity fields at the bypass entrance and occasional reverse flows.

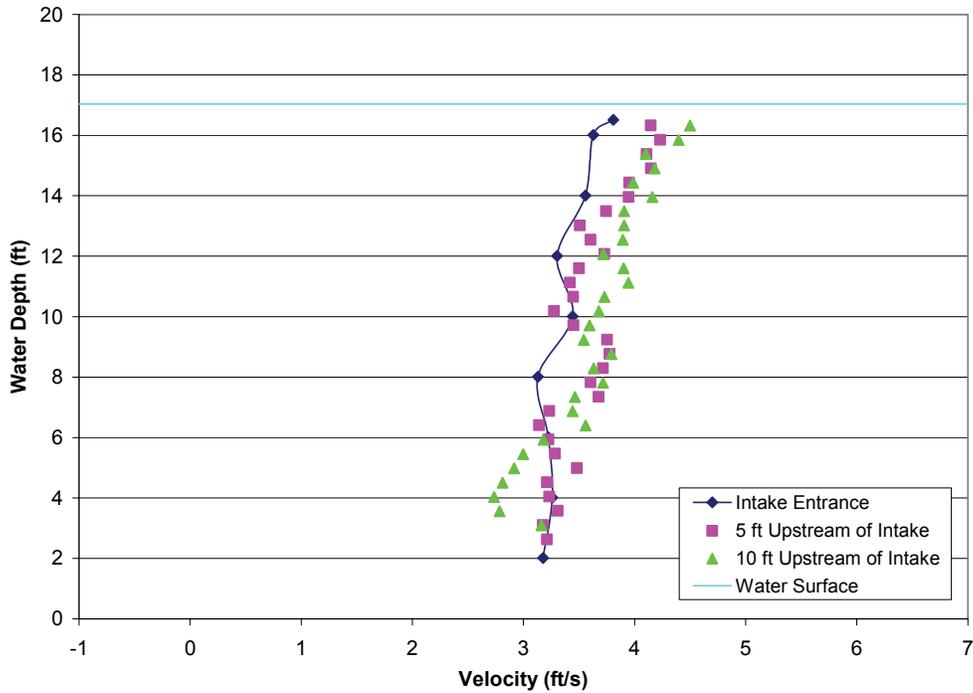
FIGURE 21.—Example of a profile collected with a bypass ratio near 1.0. Test 3-2, collected at bypass 2 with a measured bypass ratio of 1.02, shows similarly shaped approach profiles with a slight deceleration of flow into the intake.

When bypass ratios are near 1.0, profiles measured in the intake are often similar in shape to near-field velocity profiles (figure 21). This similarity in flow distribution is consistent with scale physical model results (Johnson *et al.*, 2004). Flow accelerates or decelerates gradually into the intake with little flow disruption. When bypass ratios are well above 1.0, the flow consistently accelerates into the intake as is recommended for efficient fish collection (figure 22). Since bypass ratios greater than 1.0 are difficult to achieve in the field, one or two of the four bypasses were closed during the field evaluations to force more water to pass through the open bypasses. This alternative operating method raises the bypass ratio of the open bypasses while maintaining an acceptable velocity in the secondary channel.

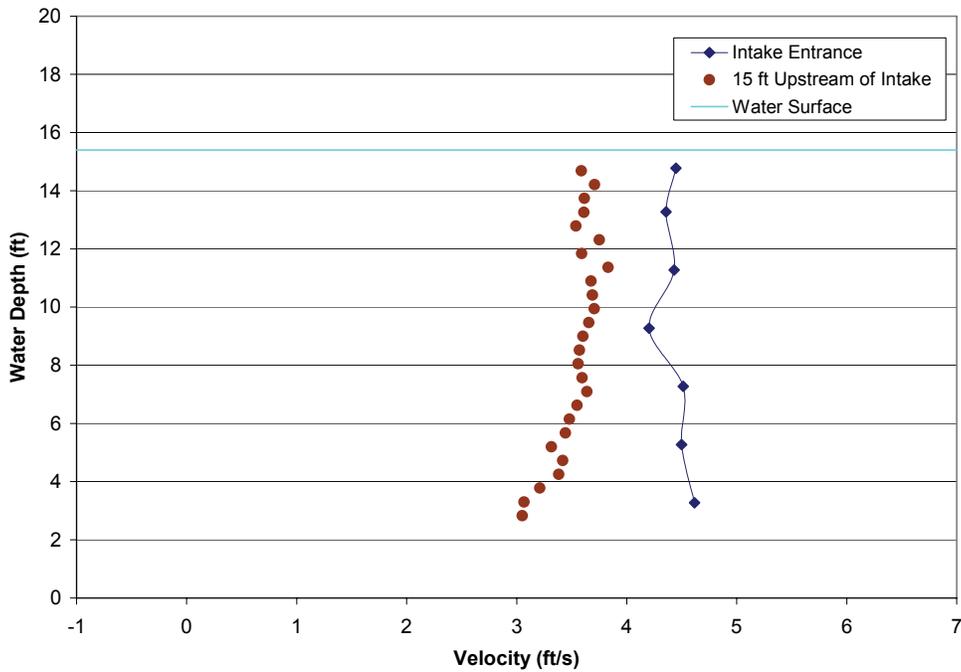
FIGURE 22.—Example of a profile collected with a bypass ratio greater than 1.0. Test 1D, collected at bypass 4 with a measured bypass ratio of 1.32, shows an acceleration of flow into the intake.

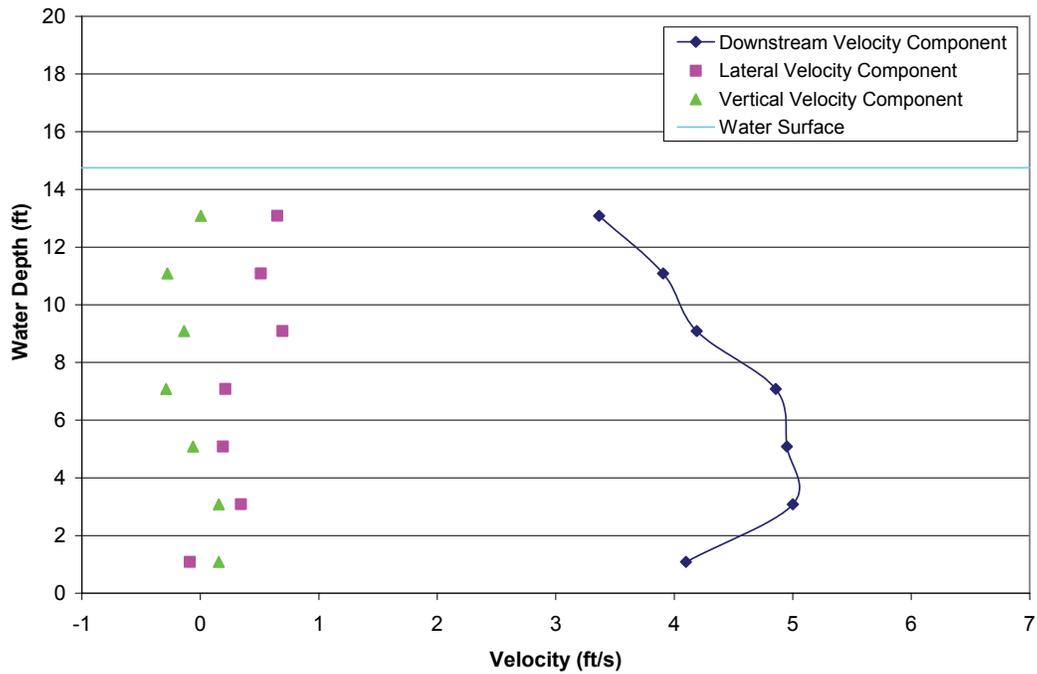
FIGURE A1-1.—Test 1A, bypass 1 intake profile with all bypasses open, measured bypass ratio = N/A, bypass ratio with facility instruments = N/A, incoming tide, water depth = 14.75 ft, recently cleaned trashrack and louvers.

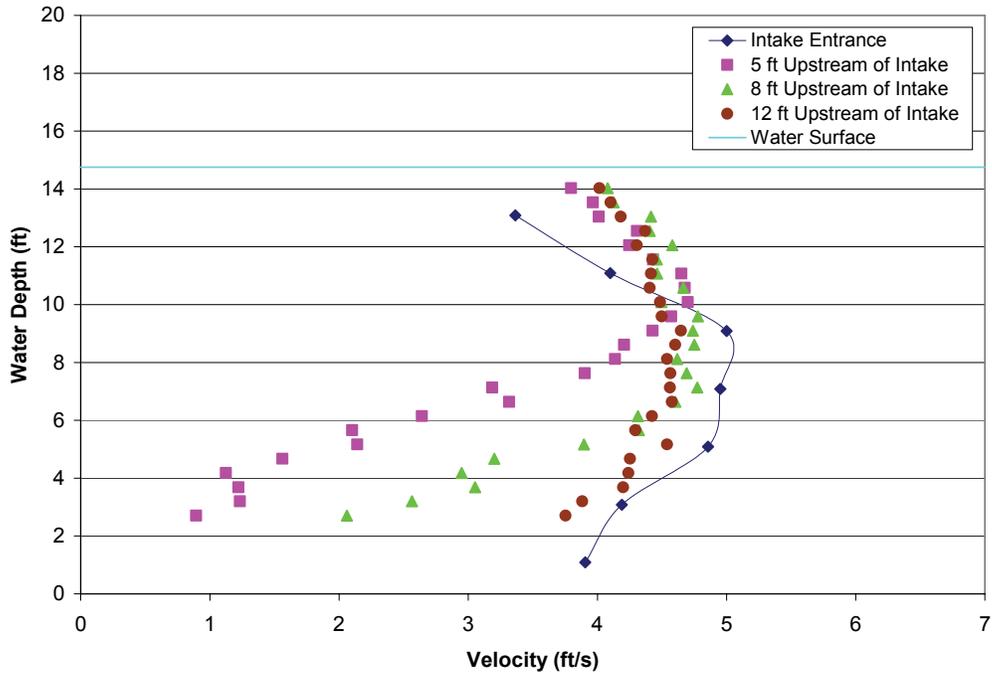
FIGURE A1-2.—Test 1A, bypass 1 approach velocity profiles against the louvers with all bypasses open, measured bypass ratio = N/A, bypass ratio with facility instruments = N/A, incoming tide, water depth = 14.75 ft, recently cleaned trashrack and louvers.

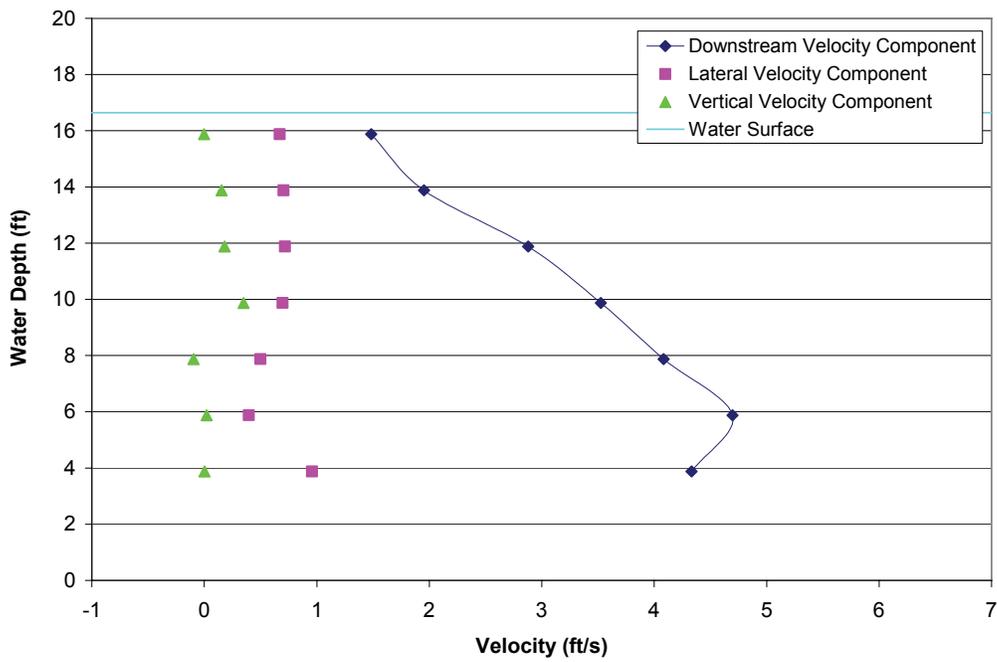
FIGURE A1-3.—Test 1B, bypass 1 intake profiles with all bypasses open, measured bypass ratio = 0.80, bypass ratio with facility instruments = 0.69, incoming tide, water depth = 16.64 ft, recently cleaned trashrack and louvers.

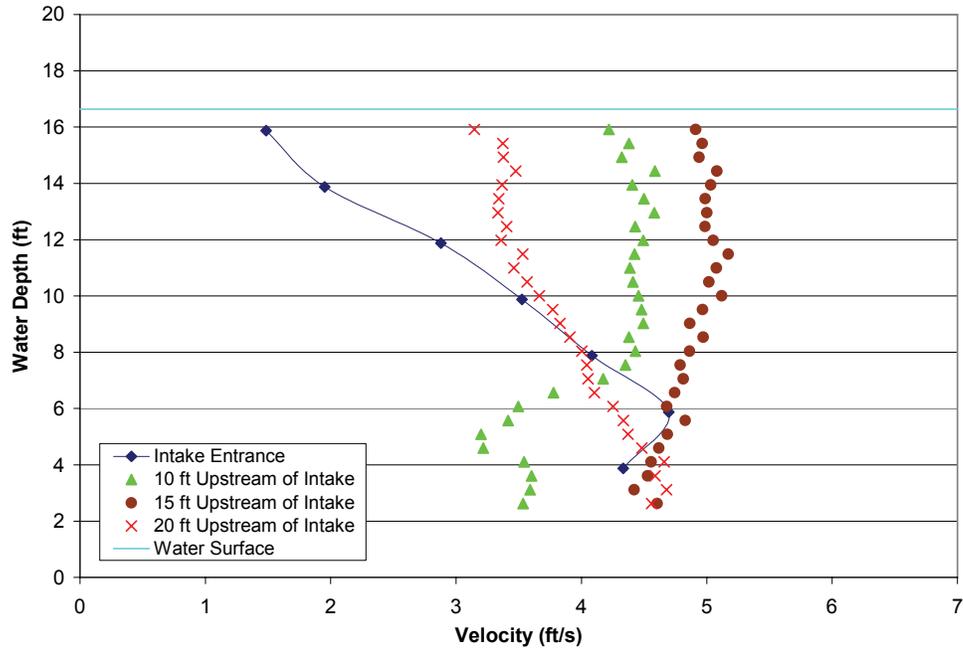
FIGURE A1-4.—Test 1B, bypass 1 approach velocity profiles away from louvers with all bypasses open, measured bypass ratio = 0.80, bypass ratio with facility instruments = 0.69, incoming tide, water depth = 16.64 ft, recently cleaned trashrack and louvers.

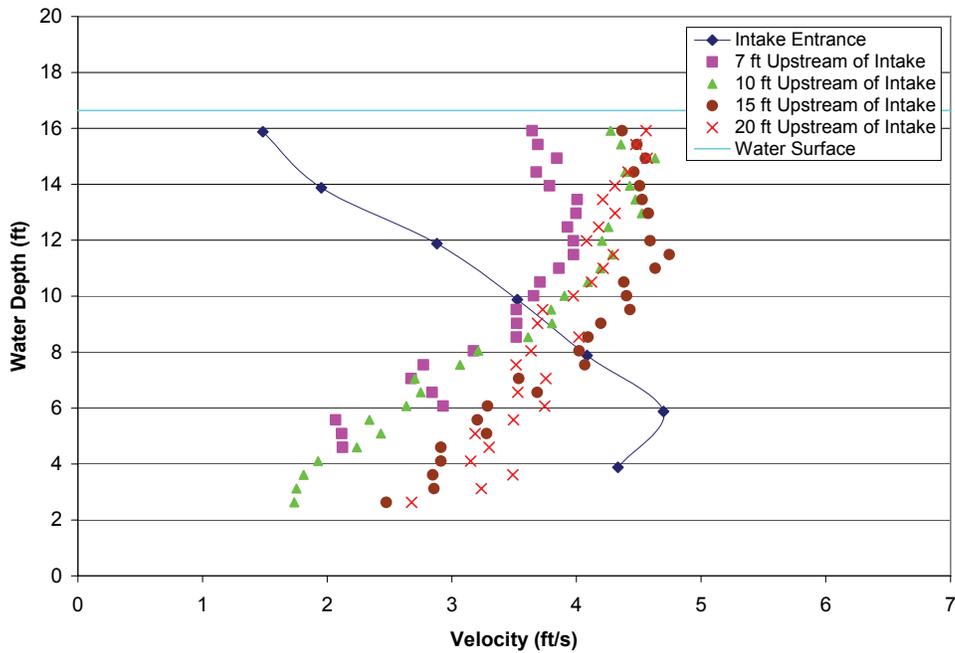
FIGURE A1-5.—Test 1B, bypass 1 approach velocity profiles against the louvers with all bypasses open, measured bypass ratio = 0.80, bypass ratio with facility instruments = 0.69, incoming tide, water depth = 16.64 ft, recently cleaned trashrack and louvers.

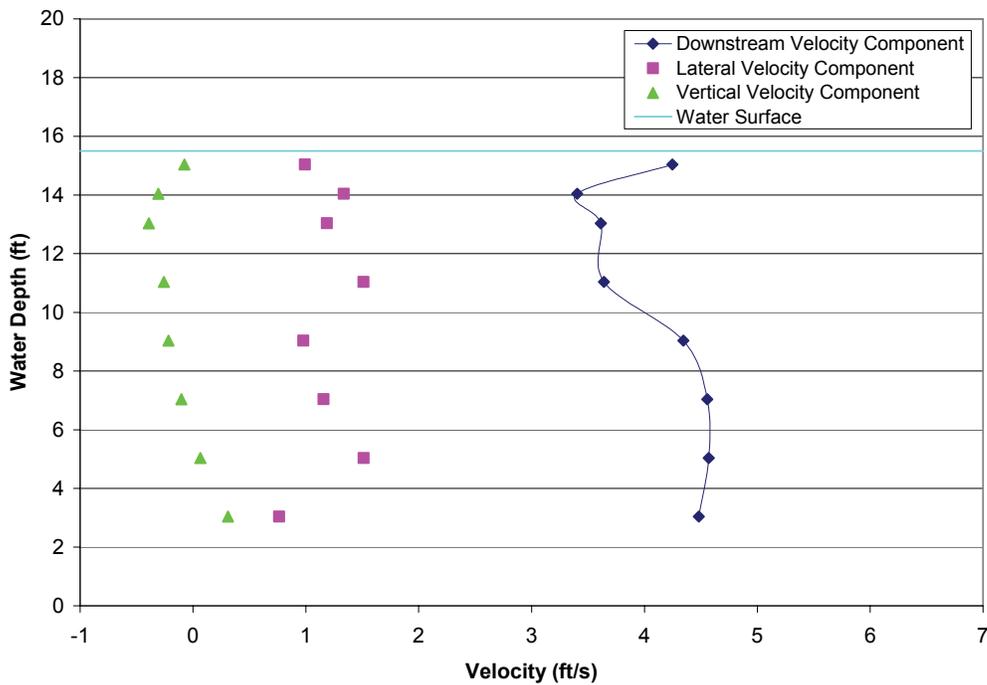
FIGURE A1-6.—Test 1C, bypass 1 intake profile with all bypasses open, measured bypass ratio = 0.83, bypass ratio with facility instruments = 0.68, incoming tide, water depth = 15.50 ft, fouled louver panel 1, clean trashrack.

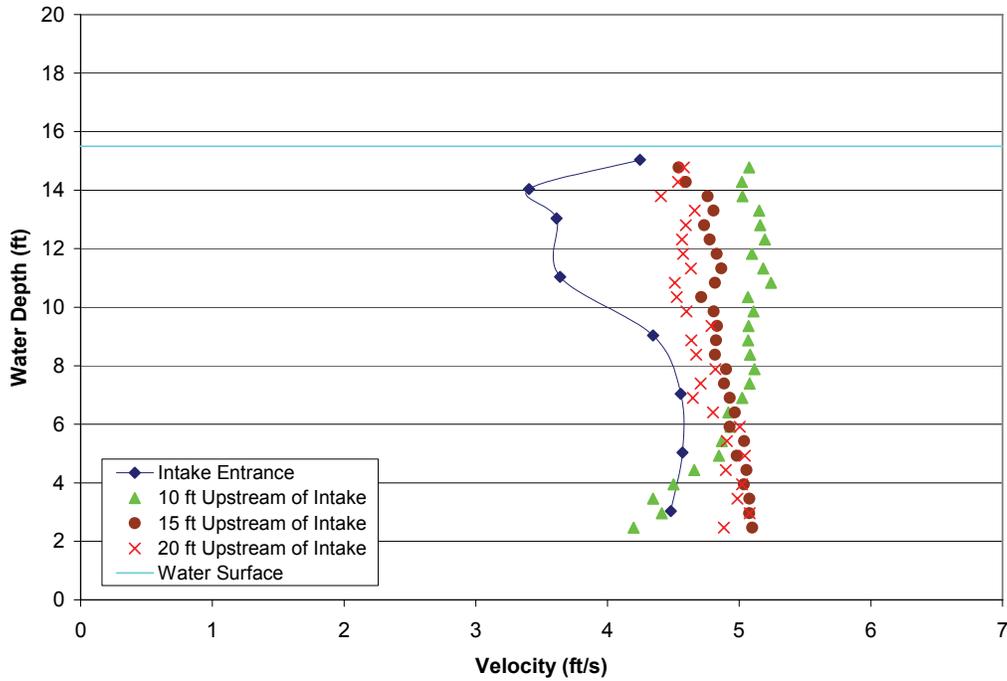
FIGURE A1-7.—Test 1C, bypass 1 approach velocity profiles away from louvers with all bypasses open, measured bypass ratio = 0.83, bypass ratio with facility instruments = 0.68, incoming tide, water depth = 15.50 ft, fouled louver panel 1, clean trashrack.

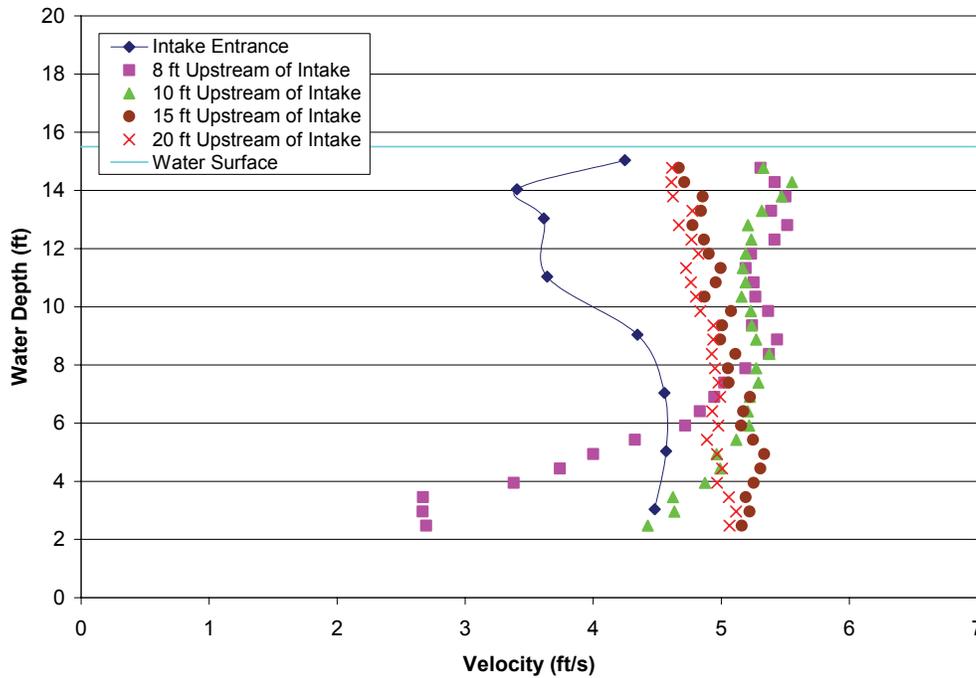
FIGURE A1-8.—Test 1C, bypass 1 approach velocity profiles against the louvers with all bypasses open, measured bypass ratio = 0.83, bypass ratio with facility instruments = 0.68, incoming tide, water depth = 15.50 ft, fouled louver panel 1, clean trashrack.

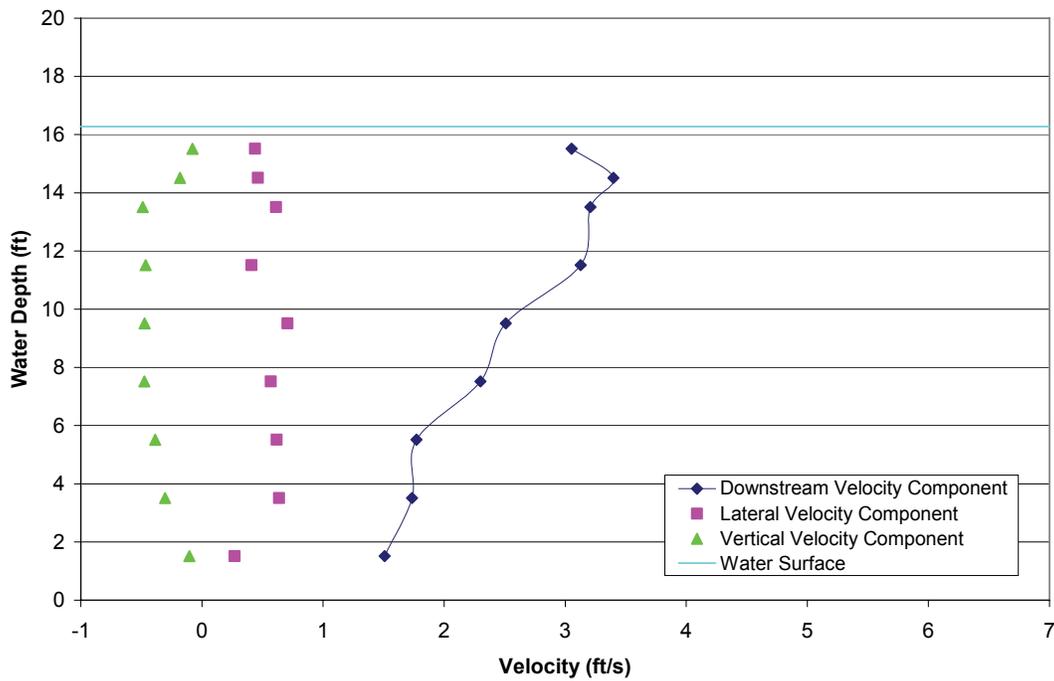
FIGURE A1-9.—Test 4A, bypass 4 intake profile with all bypasses open, measured bypass ratio = 0.69, bypass ratio for facility instruments = 0.46, incoming tide, water depth = 16.28 ft, recently cleaned trashrack and louvers.

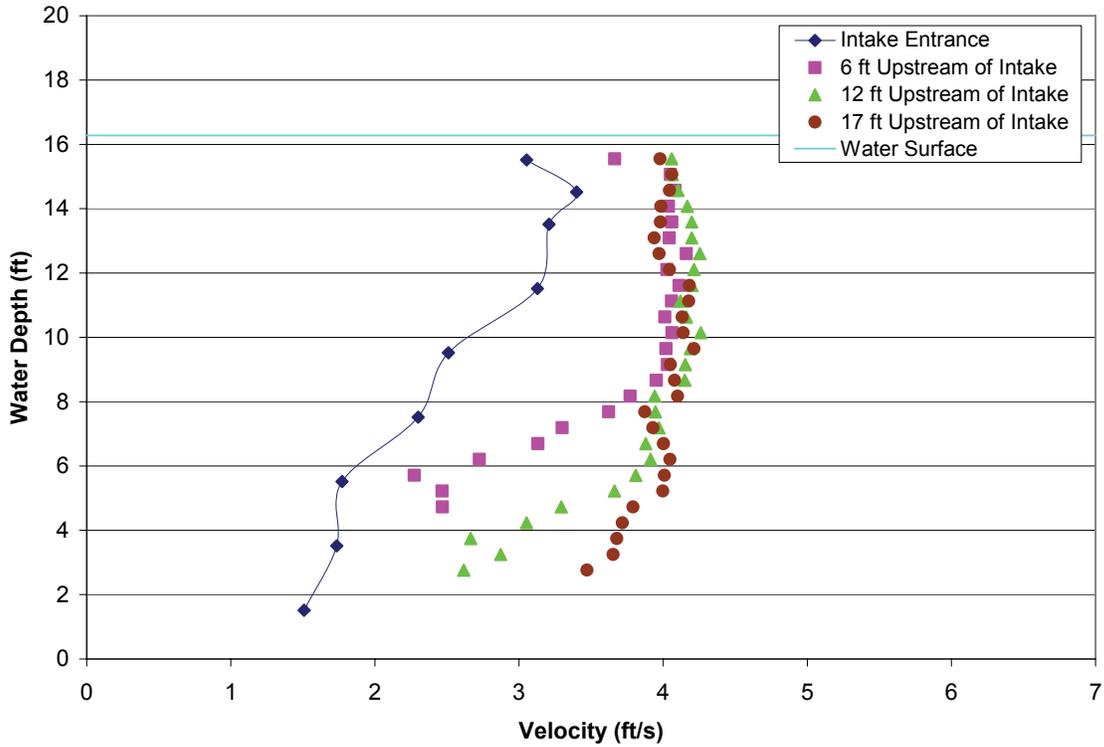
FIGURE A1-10.—Test 4A, bypass 4 approach velocity profiles away from louvers with all bypasses open, measured bypass ratio = 0.69, bypass ratio for facility instruments = 0.46, incoming tide, water depth = 16.28 ft, recently cleaned trashrack and louvers.
